ADDENDUM NO. 1

TO THAT CERTAIN DETAILED REQUEST FOR PROPOSAL FOR THE MIXED-USE REDEVELOPMENT OF 50 SUNSET AVE. AND 41 GRIFFIN ST.

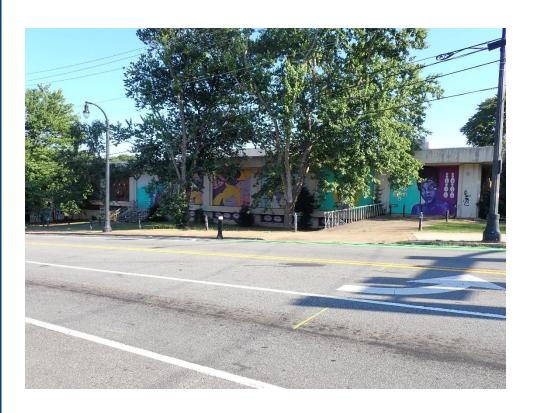
August 29, 2024 WJE No. 2024.0451.0

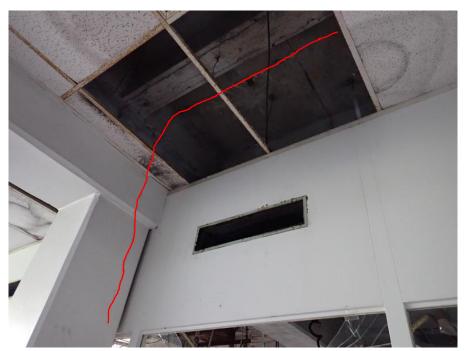
Figure 4. Cracking in western column extending through the floor slab above.

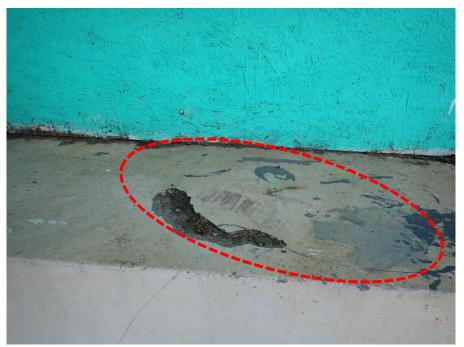
Figure 5. Delamination at top surface of Level 4 slab extension.

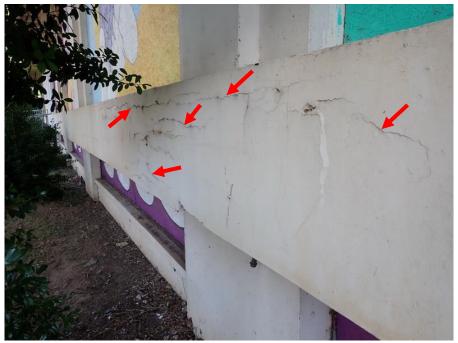
Figure 7. Cracks and delaminated concrete along Level 4 slab edge at south facade.

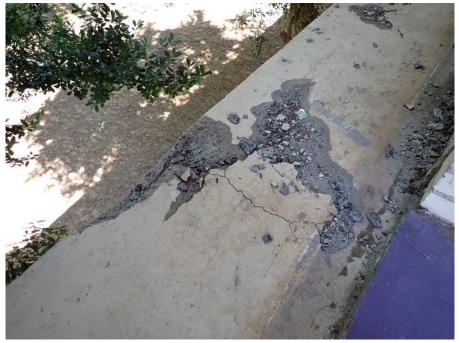
Figure 8. Spalled concrete at edge of Level 4 slab at east facade.

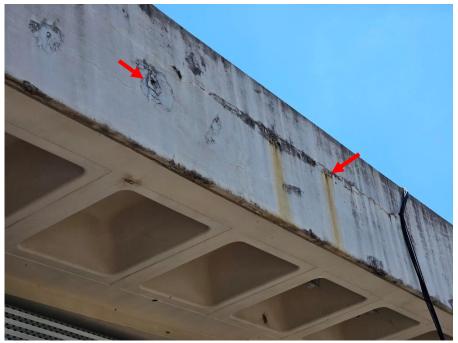
Figure 9. Spalled concrete and corrosion staining at roof edge along north facade.

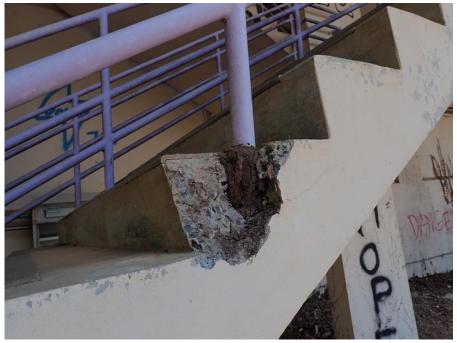
Figure 10. View of typical concrete spall at stair railing post.

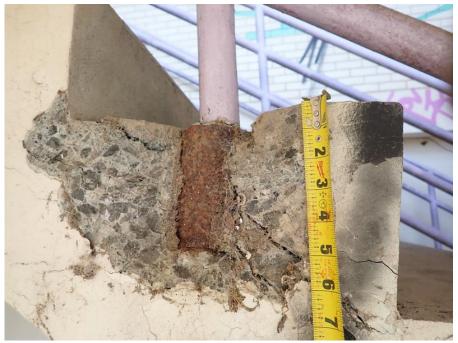
Figure 11. View of typical concrete spall at stair railing post.

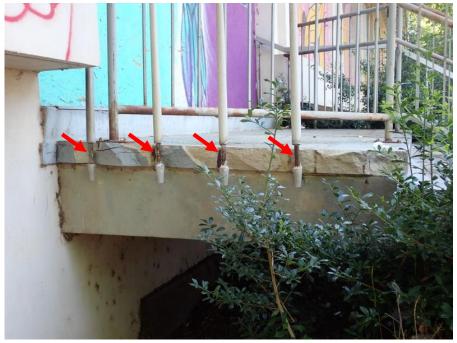
Figure 12. View of spalls along the edge of stair landing at main entrance.

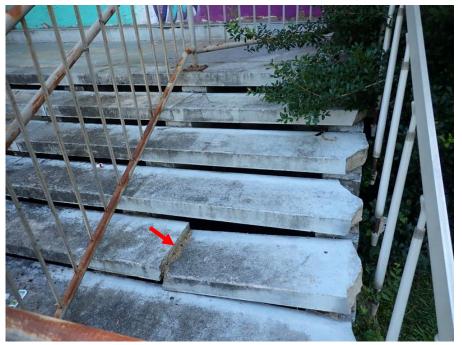
Figure 13. Broken stair tread at main entrance on south facade.

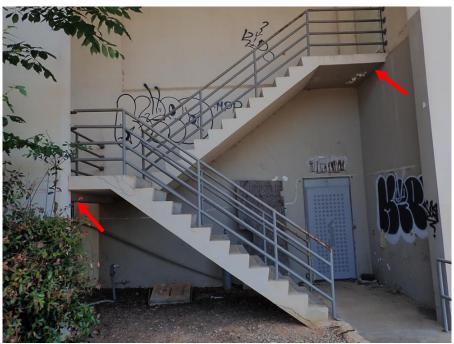
Figure 14. Overall view of the northwest exterior stairway. Locations of edge beam and wall supports indicated with arrows.

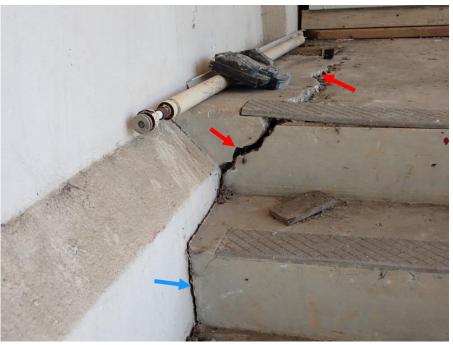
Figure 15. Crack in concrete landing at top of stairs on north facade (red arrow). Joint between north wall and stair treads indicated with blue arrow.

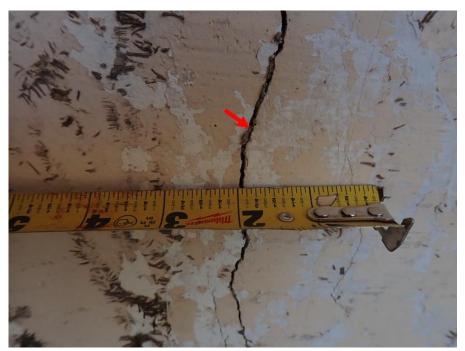
Figure 16. Vertical crack in exterior wall at north facade measures 1/8 inch wide.

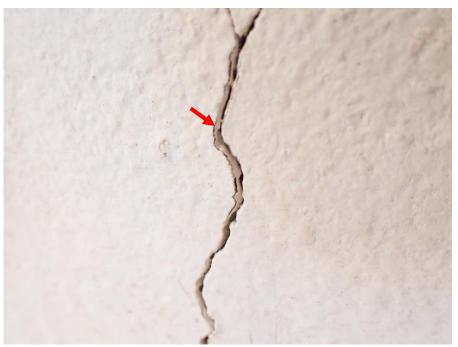
Figure 17. Paint within crack in exterior wall at north facade.

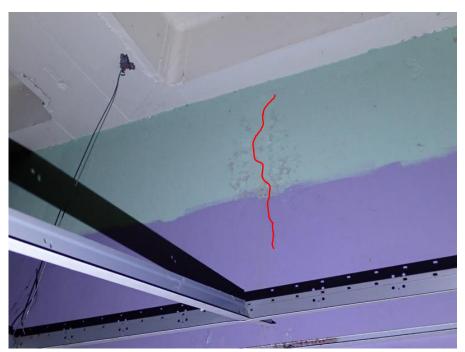
Figure 18. Vertical crack in foundation wall at south wall of building.

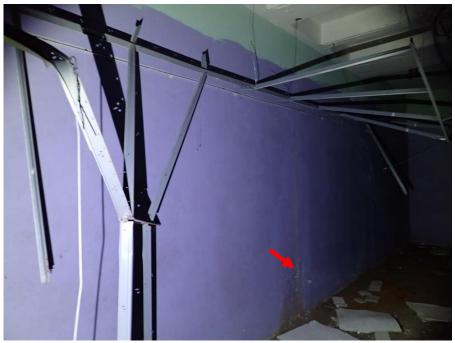
Figure 19. Water staining and bubbled paint at crack in foundation wall.

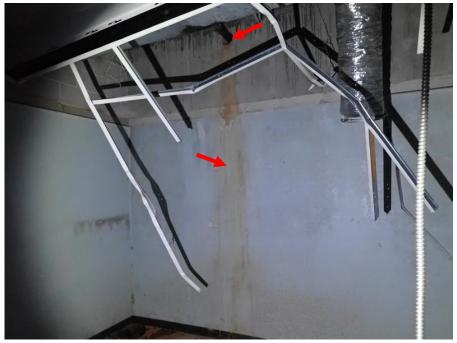
Figure 20. Soil and water staining on south wall beneath pipe penetration.

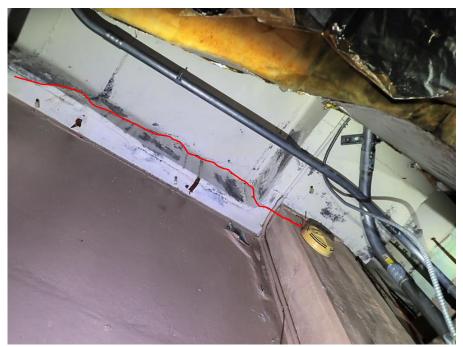
Figure 21. Horizontal crack along edge beam at Level 3 in the south wall.

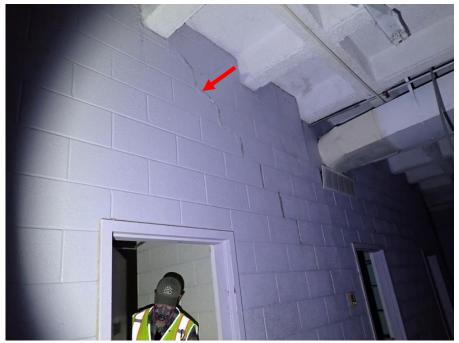
Figure 23. Sealant installed at stepped crack in interior CMU wall.

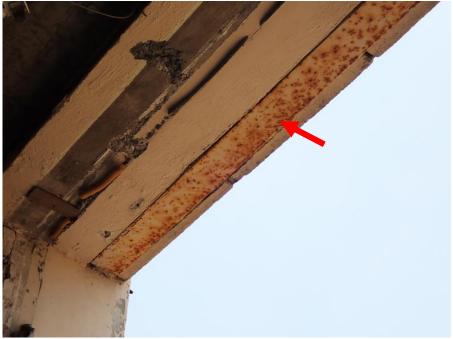
Figure 24. Light surface corrosion on steel lintel support for decorative masonry screen wall at north facade.

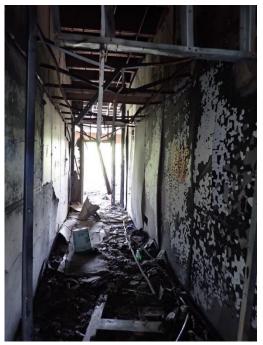
Figure 25. Overview view of interior finishes at location of December 2023 fire on Level 4.

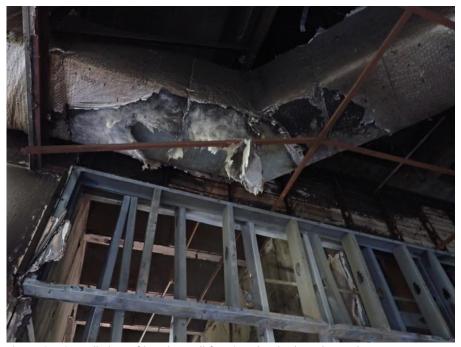
Figure 27. Overall view of interior wall framing that had not burned.

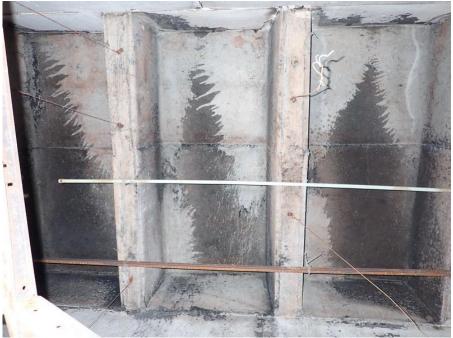
Figure 28. Limited soot staining at underside of intact concrete surfaces above Level 4 fire location.

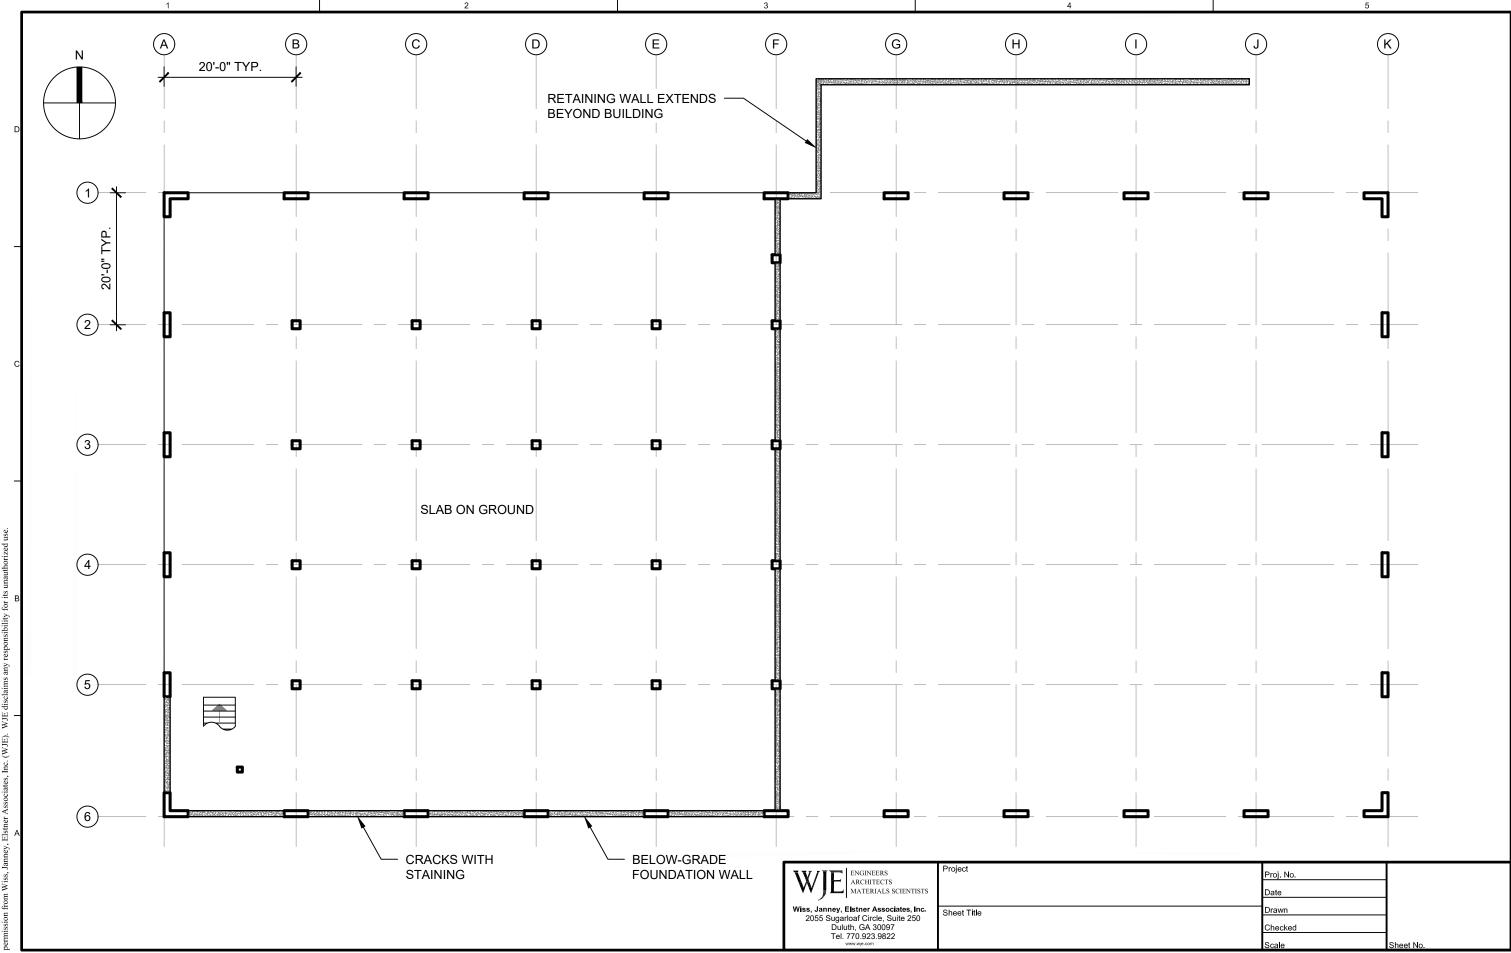
© Copyright 2018 All rights reserved. No part of this document may be reproduced in any form or by any means without permission from Wiss, Janney, Elstner Associates, Inc. (WJE). WJE disclaims any responsibility for its unauthorized use.
